Landslide disasters induced by the 2011 off the Pacific Coast of Tohoku Earthquake

Daisuke HIGAKI, Tatsuki TSUCHIYA and Misa TUSHIMA
(Faculty of Agriculture and Life Science, Hirosaki University, Japan)

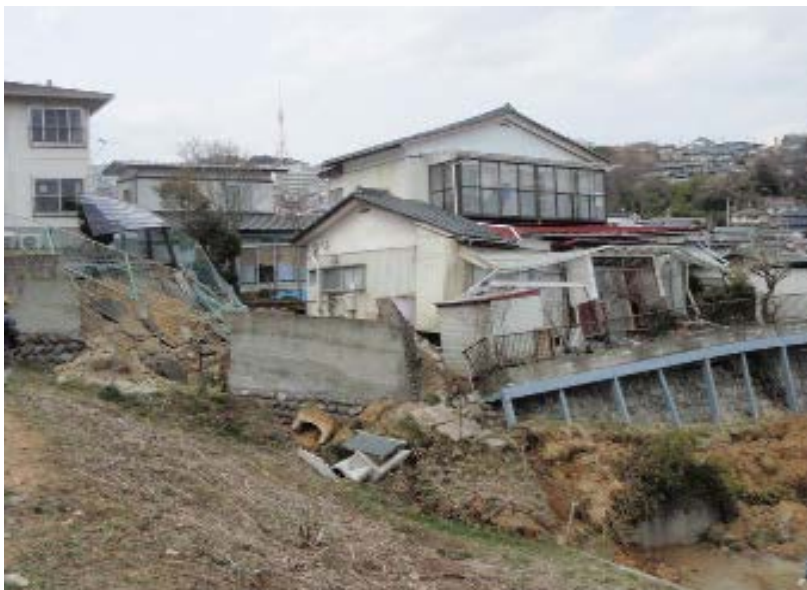
Fig.2 Houses destroyed by a
landslide in Sendai

2) In the residential areas which have been developed on the hills composed of the Pliocene to Pleistocene sediments, slopes of earth-fill have been deformed by many cracks, steps, slides, and thus many houses were destroyed in Sendai city with 788 square kilometers in area (Fig 2). Many of them occurred by the main shock on 11th March. After that, many after-shocks have made further deformation. Such slope deformation also appeared in southern part of Miyagi and Fukushima Prefecture, so large number of residents have been evacuating.

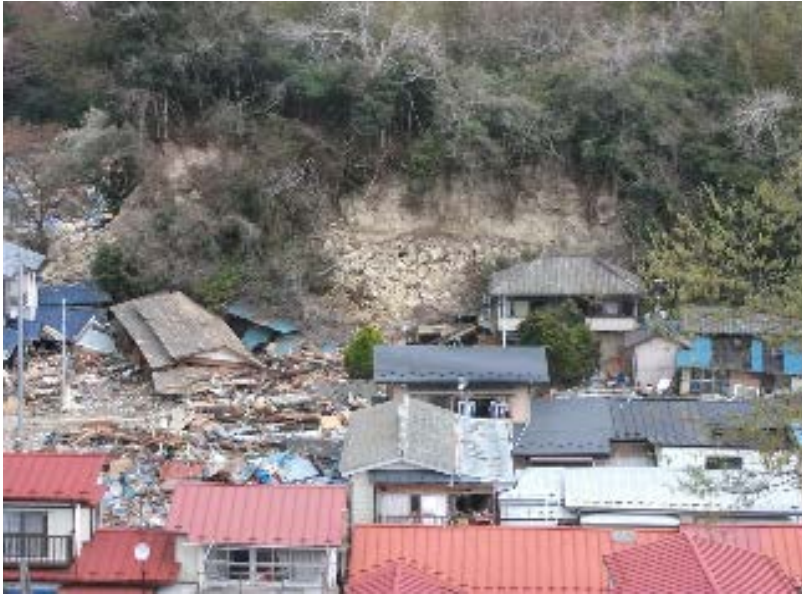
Fig.3 A slope failue in Sabusawa Island (Tsunami from left side also destroyed the houses

3) On Matsushima coast area of Miyagi facing Pacific Ocean of the Neogene volcanic deposits with mudstone/sandstone, many slope collapses occurred in the islands (Fig 3).

From interview and fieldworks, many of them occurred during the main shock and soon Tsunami attacked the residential area.

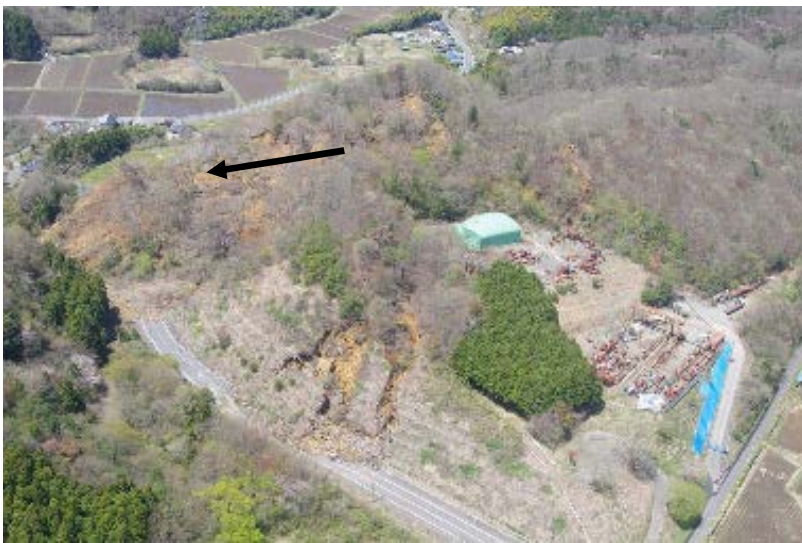
Fig.4 A deep-seated slide blocked a highway in Iwaki

5) On the south eastern areas on Iwaki city happened magnitude 7.1 inland earthquake on 11th April , land surface deformation appeared along the Idosawa fault (Shionohira fault) and Yunodake fault during this earthquake. Many rock slides and deep-seated landslides occurred in the surroundings of faults to coast areas of the Pacific Ocean (Fig 4).

In this area, landslide disasters happened on the slopes consisting of the Neogene and Paleogene strata and the crystalline schist area. Since them some of slopes have been still unstable due to after shocks and rainfall, so it is urgent to distinct movement rate and risk of them.
